Figure A1.4: Outcrop photo of exposure in the inactive Loring quarry. Members of the Farley are outlined as are the surrounding units. Note that the Bonner Springs Shale is absent in this location. Aggregate sample locations are also noted.

Location Loring Quarry

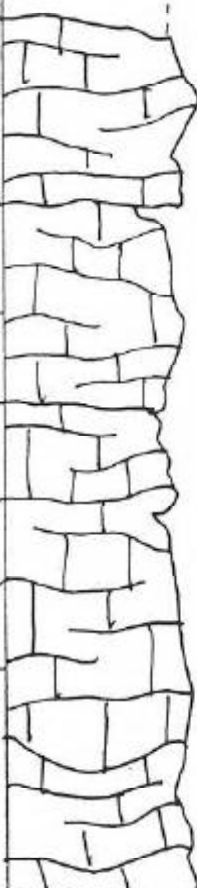
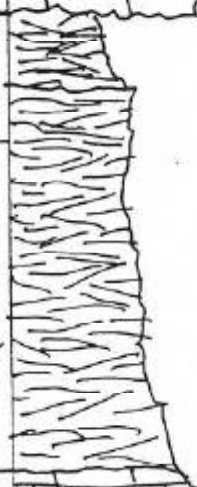
Phyl. Algal Wackestone	Spumose ab. in cracks & fossils (~25-30%)		L-5		Continues up out of reach. Large shallow pores & fractures filled w/ coarse spm.
28		Q#8		Ostrac. Brachiopod Wackestone	Coarse spm in brachia & other fossils (~10-15%)		KD-11		Ostrac. very ab. as are Composita. Echinoderms more ab. @ the base.
65cm

Q#8		Fossilif. Siltstone					Skeletal pieces @ very base. Most fossils/brachia near the top. Calcareous throughout
6cm									
3cm

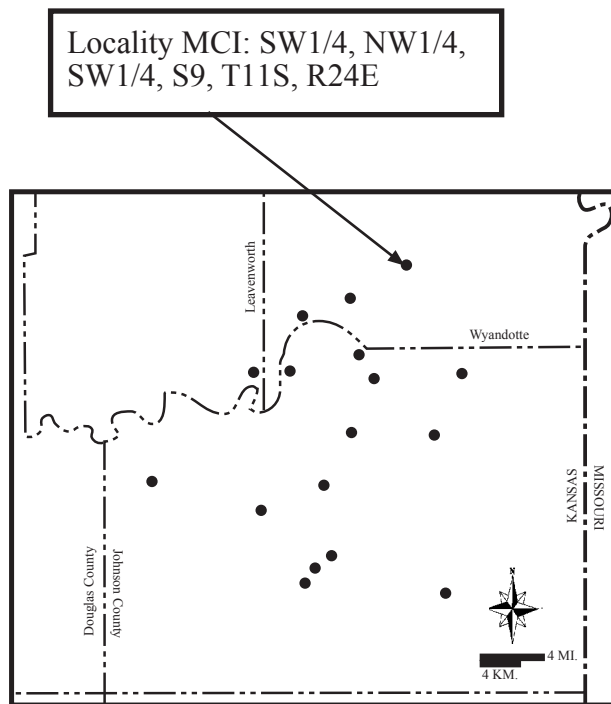
Locality MCI: Roadcut/outcrop. Located north of Interstate 70 in Wyandotte County. Measured section was compiled from two localities. The Farley Limestone was measured from the outcrop located at the Motor Carrier Inspection Station on I-70. The Island Creek was measured approximately 1 mile to the west along the north side of the 78th Street westbound exit ramp.
